# Home Report

Flat 2/1  
133 Byres Road  
Glasgow  
G12 8TT

# single survey

<b>Property address</b>	Flat 2/1 133 Byres Road Glasgow G12 8TT
<b>Customer</b>	City Property (Glasgow) LLP
<b>Prepared by</b>	Graham + Sibbald LLP

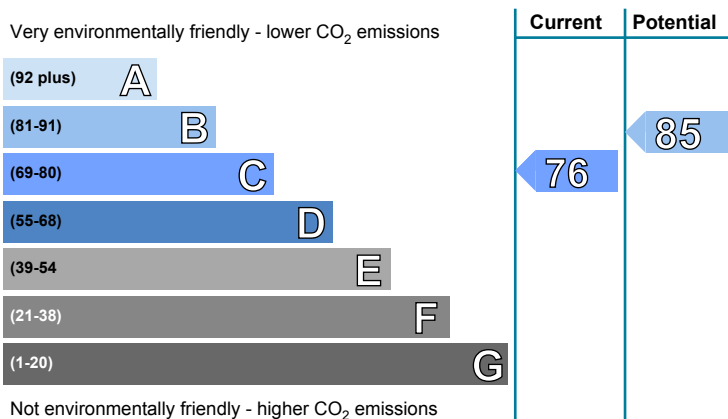
## Environmental Impact (CO<sub>2</sub>) Rating

This graph shows the effect of your home on the environment in terms of carbon dioxide (CO<sub>2</sub>) emissions. The higher the rating, the less impact it has on the environment.
